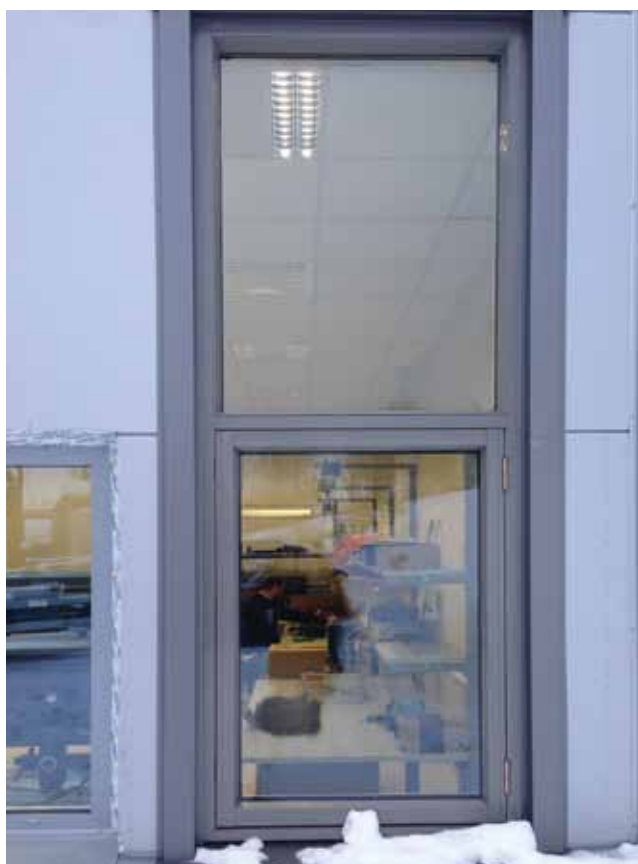
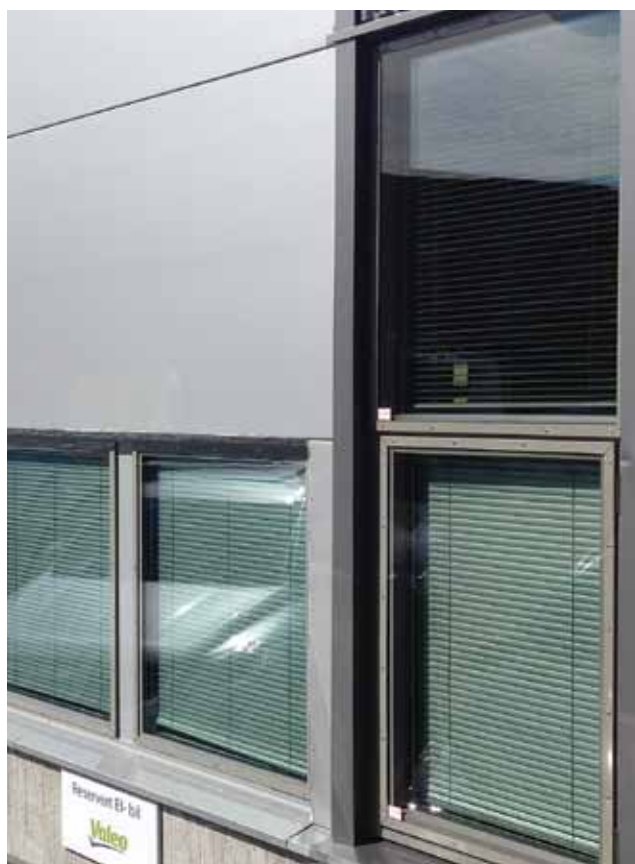
Object:	Valeo Powertrain Energy Conversions AS, Norway 2014
System:	Hammerglass Add-On System U, 8 mm
Performance:	Mil Sec Norway
	<p>Securing of exposed ground floor windows of laboratories.</p> <p>Hammerglass 8 mm mounted in RAL-coloured Hammerglass Add-On System U.</p>

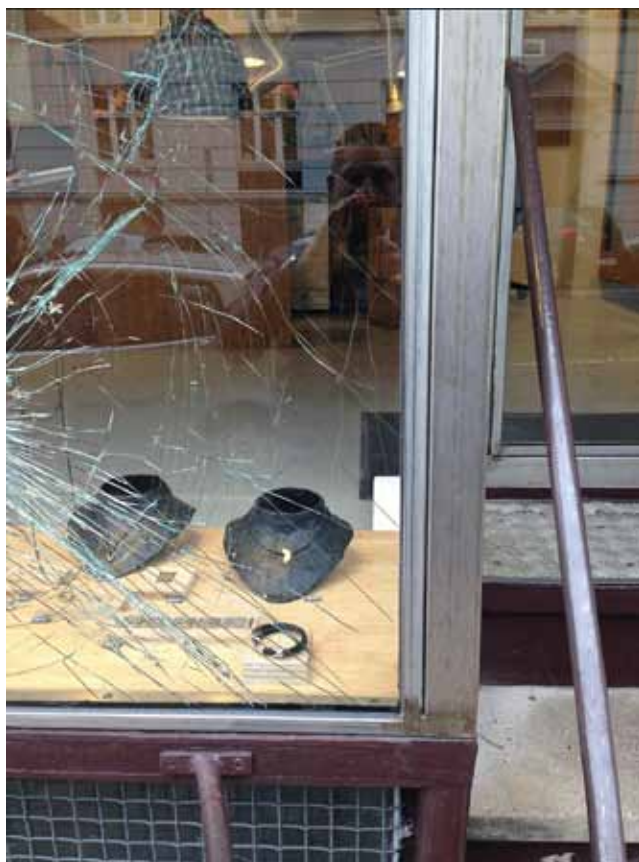
Object:	Jeweller Nicolai Appel, Denmark 2013
System:	Hammerglass Single 12 mm
Performance:	Hammerglass Single 12 mm
	<p>Hammerglass Single 12 mm was installed in the shop window and door of Jewellery Store Nicolai Appel, to avoid future glass breakage.</p> <p>Security Class EN 356, P8B.</p>

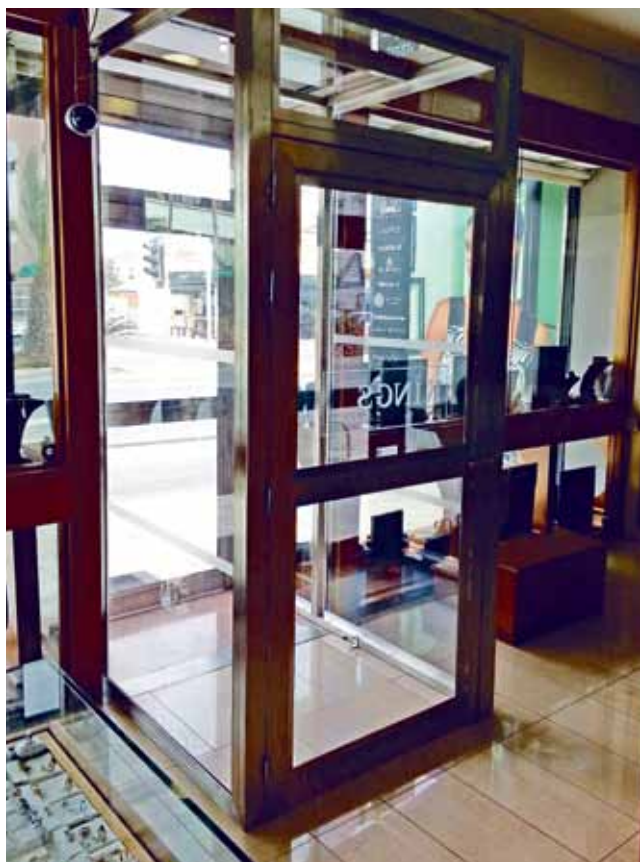
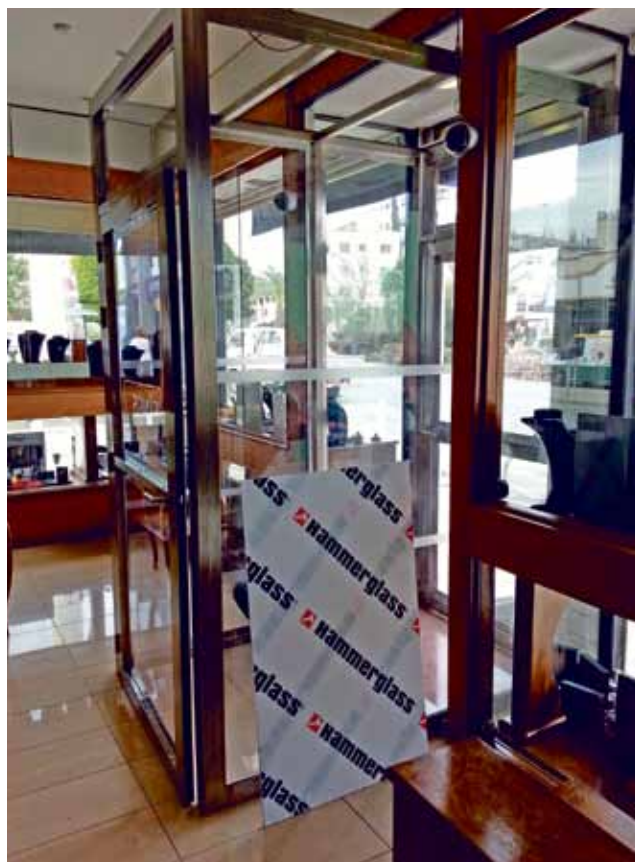
Object:	Kings Jewellers, Lemesos, Cyprus 2013
System:	Hammerglass Single 10 mm
Performance:	Lemoniatis Window Films, Limassol
	<p>A security enclosure/booth with double doors in stainless steel, all equipped with 10 mm Hammerglass.</p>

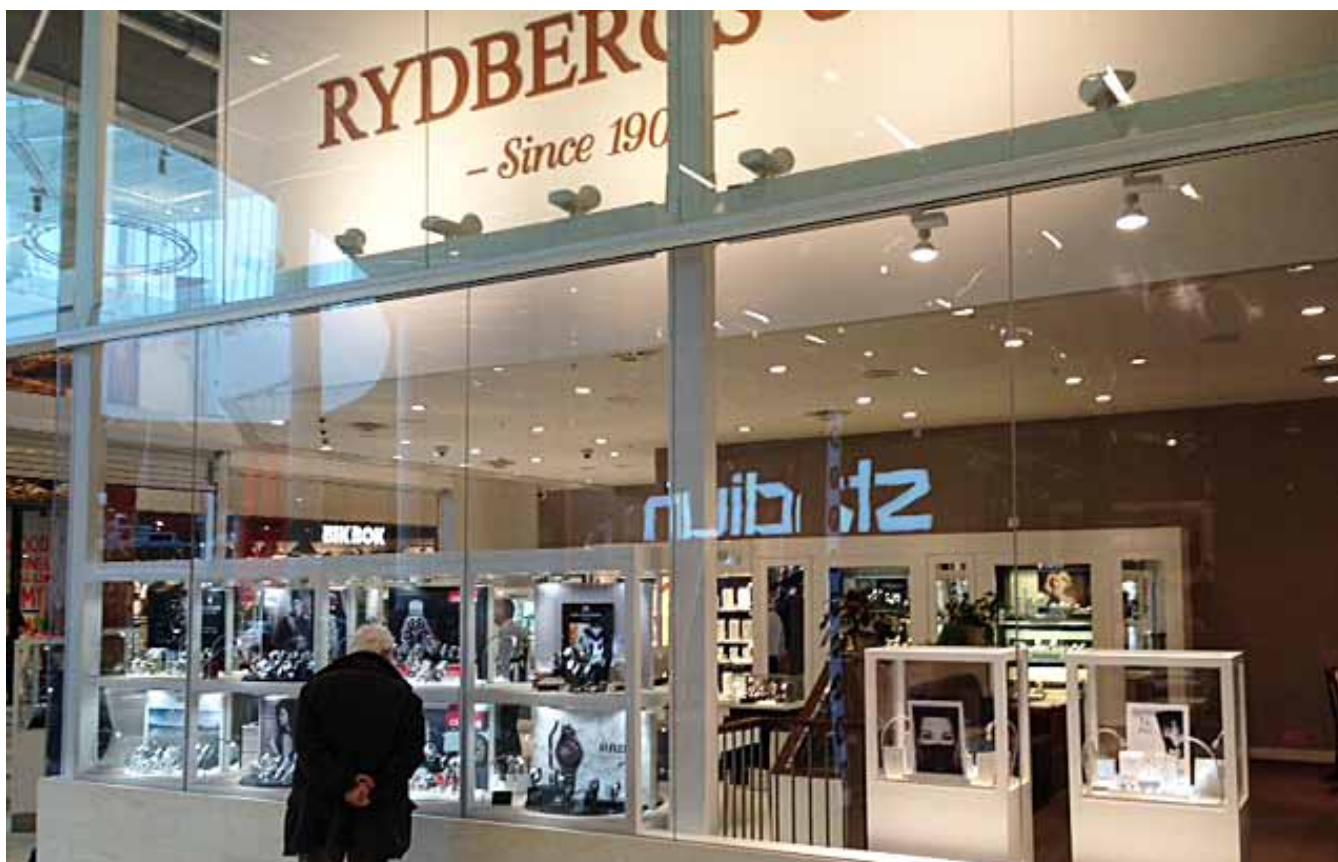
Object:	Rydbergs Jewellery and Watches, Väla, Sweden 2012
System:	Hammerglass 12 mm, tongue and grooved system
Performance:	xxx
<p>Hammerglass 12 mm mounted in profiles at the top and bottom of the windows. Vertical tongue and groove system.</p>	
<p>Secured by Design</p>

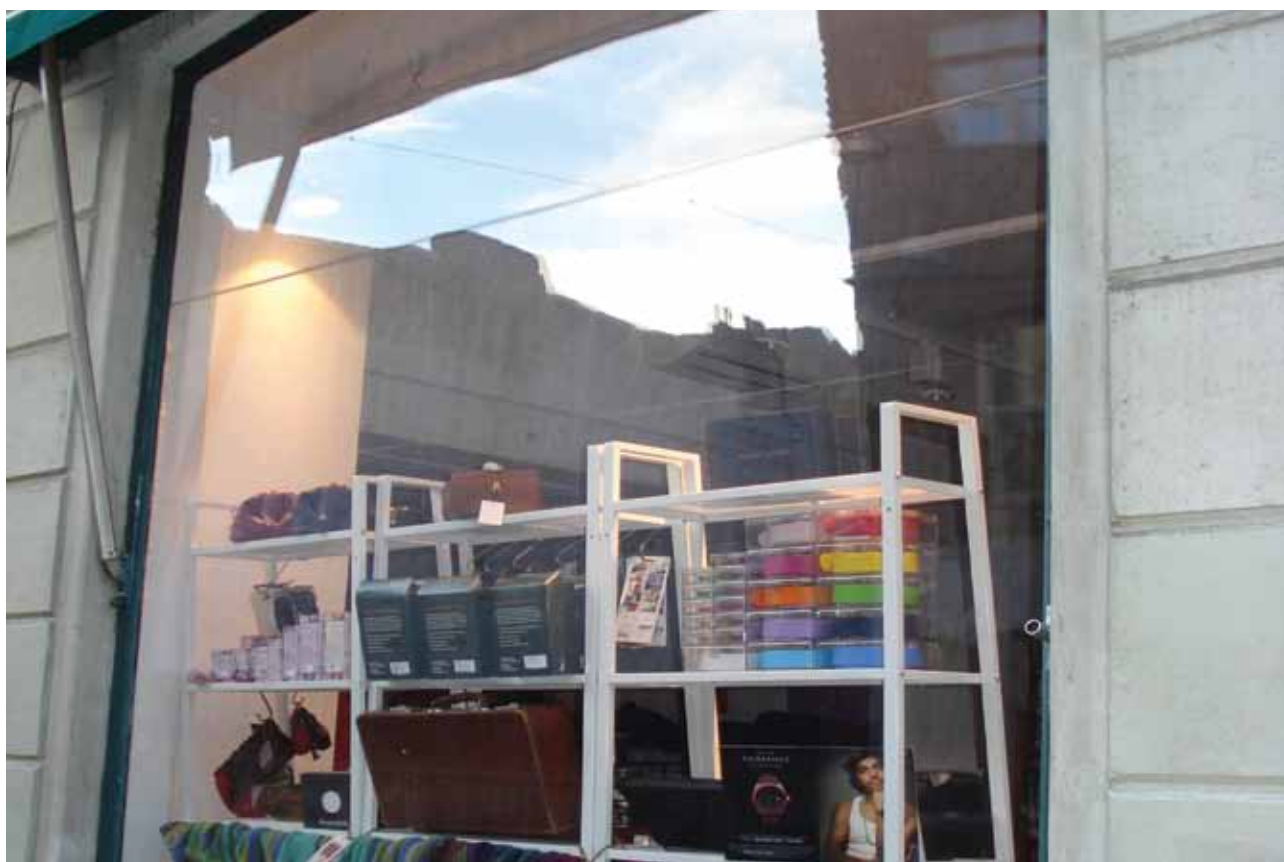
Object:	Scandinavian Sportsman, Lund, Sweden 2010
System:	Hammerglass Single 12 mm, tong and grooved system
Performance:	Gallerexperten
	<p>Animal rights activists have repeatedly exposed the shop for vandalism. Hammerglass Single was mounted in the existing arches of three windows with curved upper sections.</p> <p>Following the Hammerglass panels size limit (2x3 m), the panels were spliced with a tongue and groove system at two metres height.</p>

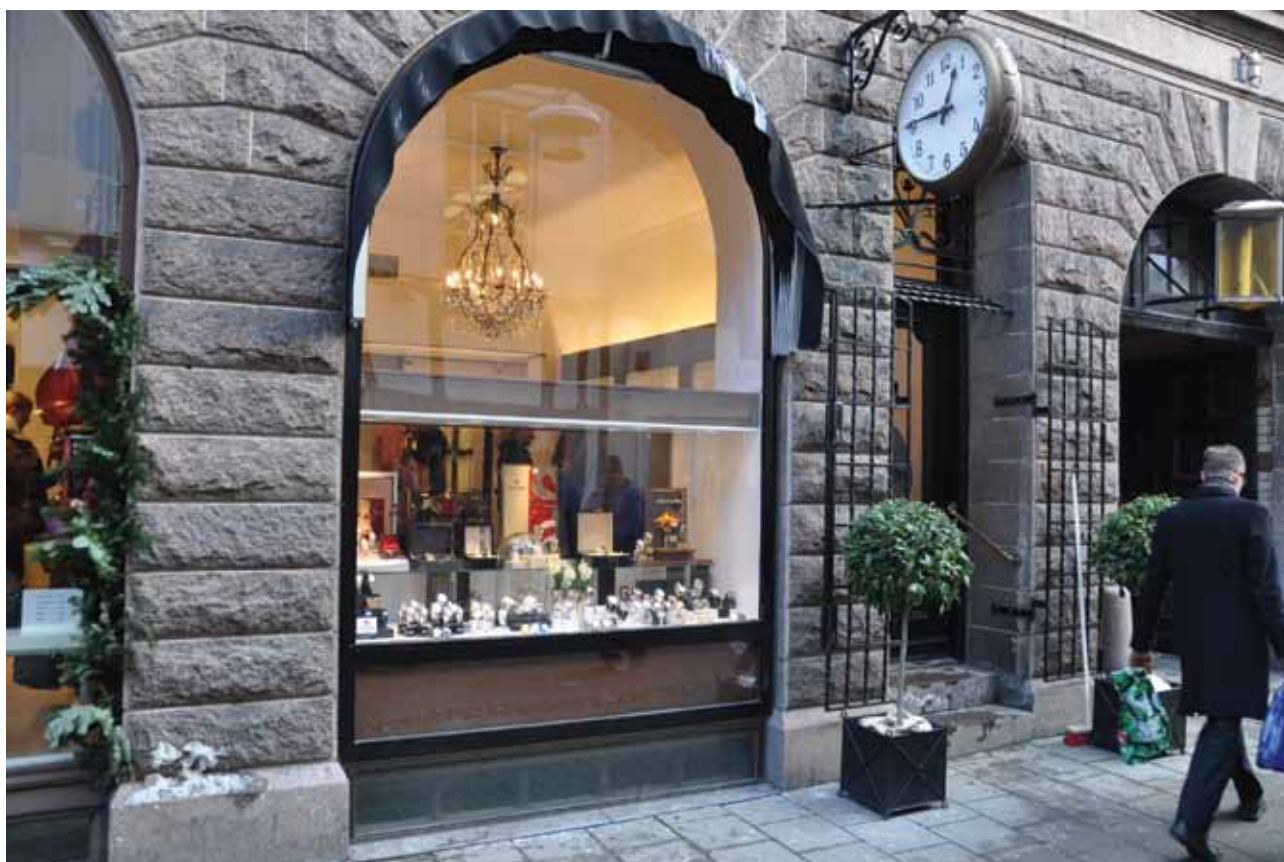
Object:	Carlssons Ur, Helsingborg, Sweden 2009
System:	Hammerglass Single 12 mm
Performance:	Gallerexperten
	<p>Hammerglass Single 12 mm installed in existing wooden sashes in arched shop windows and entrance door. Security class P8B.</p> <p>Cold rolled steel profile in window bar (bottom of the window) prevent vehicles to drive through.</p> <p>The window glass is coated with a scratch-resistant SafeCoat film.</p>

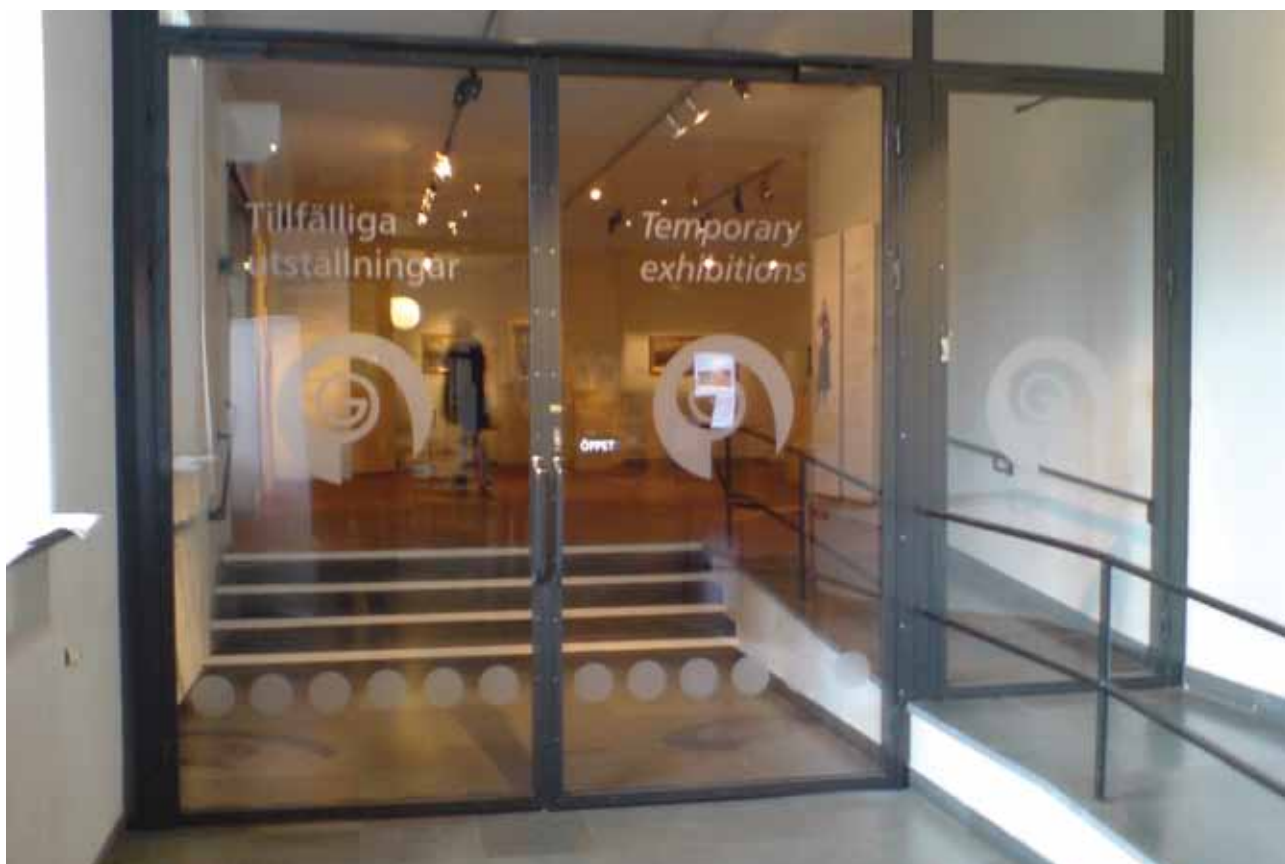
Object:	County Museum, Gävle, Sweden 2009
System:	Hammerglass Single 8 mm
Performance:	Låstjänst Alarm, Gävle
	<p>In the exhibition areas, Hammerglass Single 8 mm was installed on specially manufactured cold rolled steel profiles and window. Its low weight (10 kg/m² compared to approximately 75 kg/m² for laminated glass) provide a smooth and easy installation.</p> <p>Security class EN-356, P8B.</p>

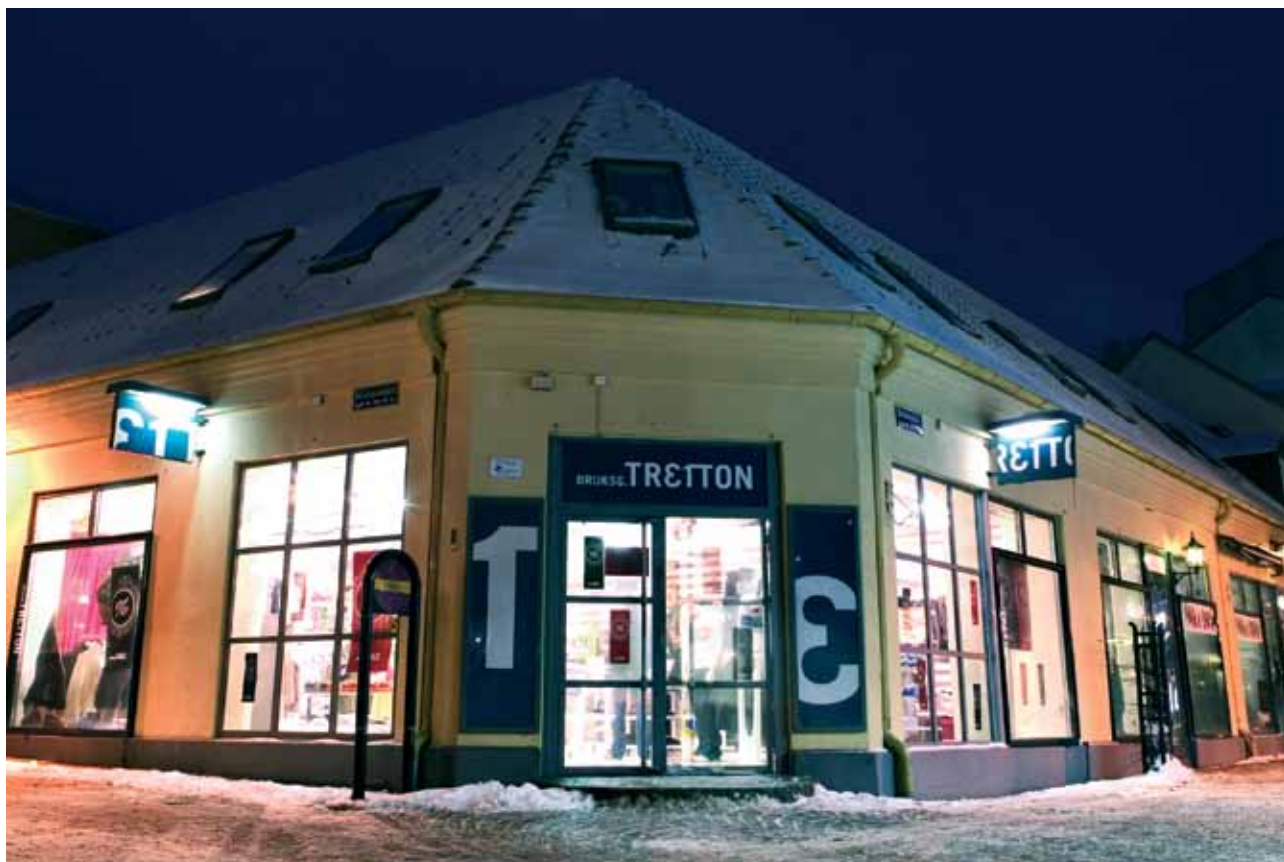
Object:	Bruksgatan No 13, Helsingborg, Sweden 1996
System:	Hammerglass Single
Performance:	Metallfasader
	<p>Hammerglass Single was installed in new steel profiles in the storefront and entrance party. The Hammerglass panes were glued into the frames and the glazing beads were fixed with screws.</p> <p>Forester Profile system.</p>
<p>Secured by Design</p>
